GAS SAFETY UK - CLIENT UPDATE FOR OCTOBER 2002.

UNDER PRESSURE?!

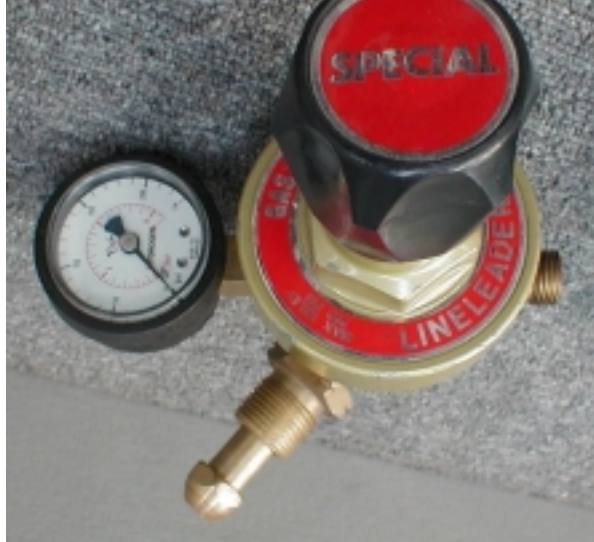
Photograph 1.

Photograph 1 (above) and Photograph 2 (below) are prime examples of the unsafe modification of gas control equipment. These examples were discovered during our annual audit and inspection of regulators at the site of one of our clients. It may be clearly seen that in both cases, pipeline outlet regulators with a maximum working pressure of 200 psi have been modified for cylinder mounting & would, therefore, have been subjected to pressures of 3,000 psi or more!

Both of the cases highlighted in this month's 'Update' have underscored the misguided tendency of some people to 'lash' things together. Whilst it is plausible that such actions may stem from blissful ignorance - even to the point of ignoring the regulator labels of 200 psi and the nature of high pressure gases (let alone that these regulators were for hydrogen and oxygen use), another root cause seems more likely; thrift. We are continuously battered with requests to save money, to recycle materials and the like alongside a well entrenched tendency in many individuals to 'make do & mend'. Perhaps, then, it should come as no surprise that the results of such creative & potentially destructive activities may be discovered from time to time?

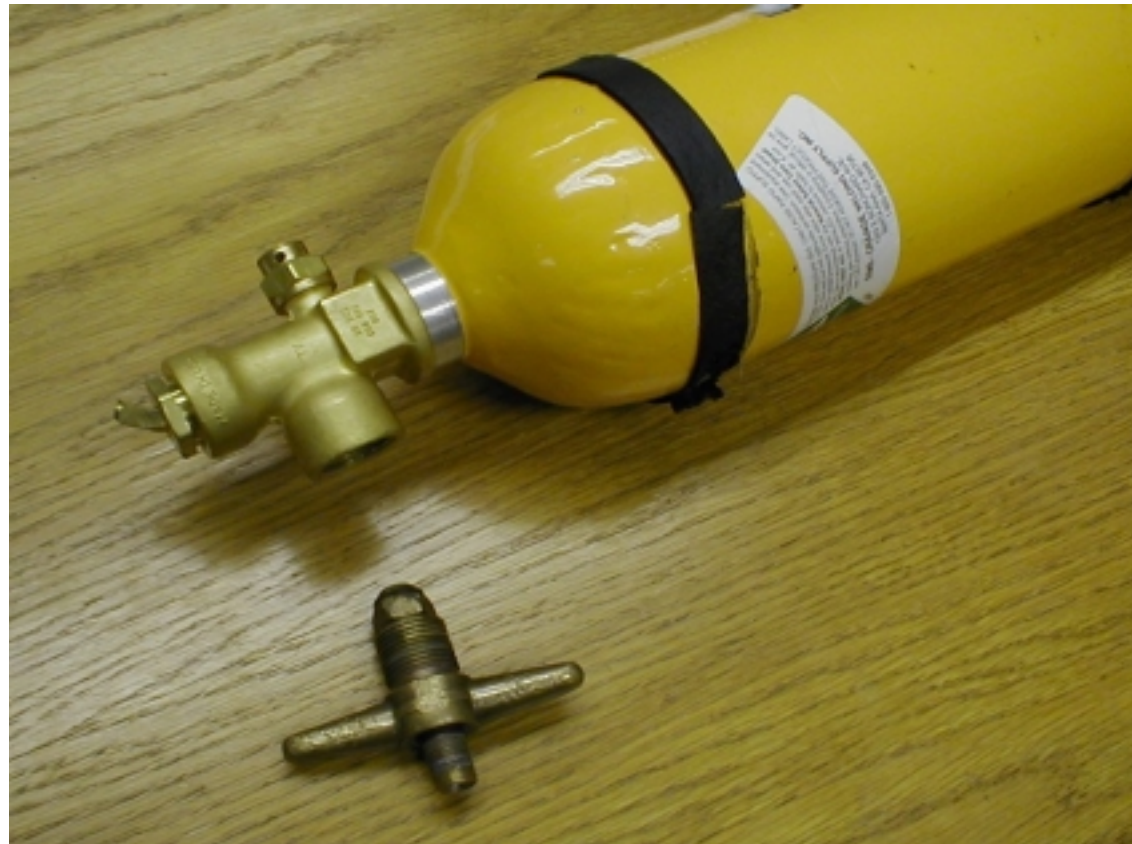
Photograph 3.

Photograph 3 (below) are some of the remains from a recent mishap which occurred when an attempt was made to re-fill a small nitrogen cylinder. Clearly, cylinder re-filling (or decanting) is not recommended practice unless specialist equipment, training, etc. are in place. However, in the example below, failure to danger occurred during filling because of a mis-match between the donor and the recipient. The recipient cylinder was from the U.S.A. &, as you'd expect, came equipped with a CGA 580 type outlet to it's valve. On the other hand, the donor filling line terminated in a standard U.K. nitrogen (BS 341 No. 3) type fitting. This was similar in outward appearance to it's American counterpart - but, sadly, not the same! From the outset, this operation (however well intended at the time) was doomed to miserable failure.
